Facility: Thomas Hayward Agriculture & Nutrition

Subject: Area in front of the facility (on the south side of the property) looking west with the Harcros facility in the background.

RCRA 6/27/1995

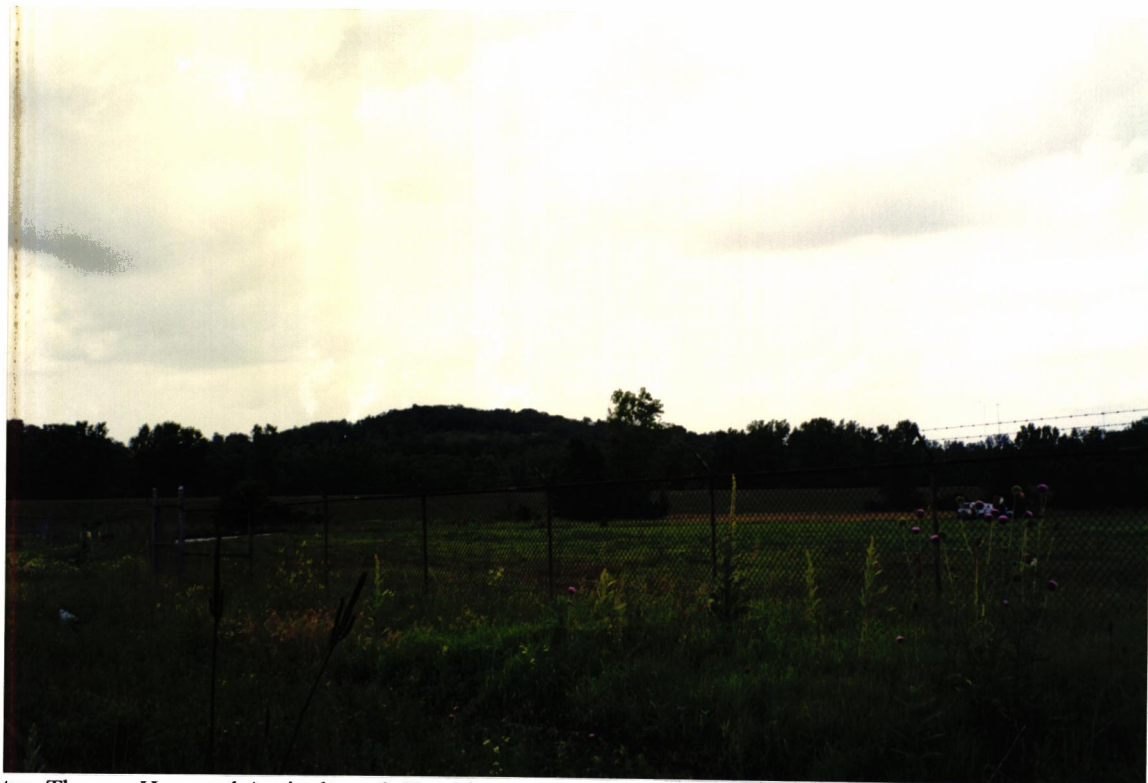
9

Subject: The former THAN surface impoundment (the area behind the fence). Note the monitoring well in the foreground (far right side of the photo).

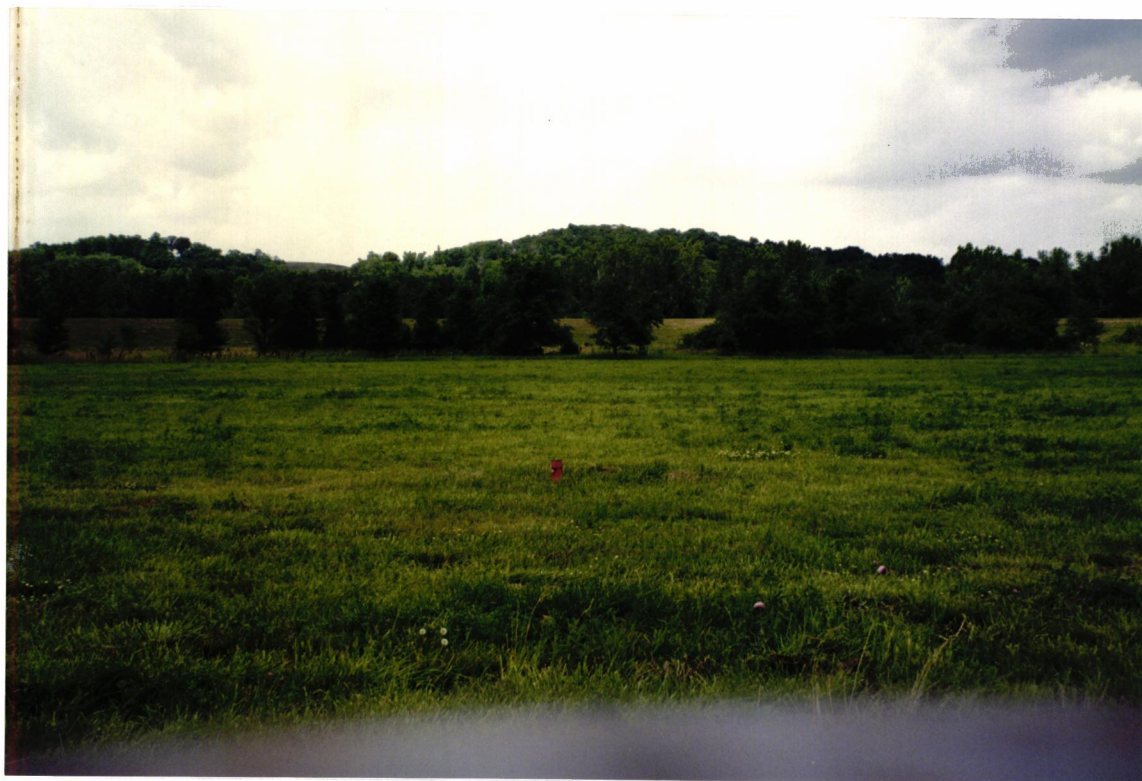
10

Subject: The former THAN surface impoundment. Note monitoring well in the foreground.

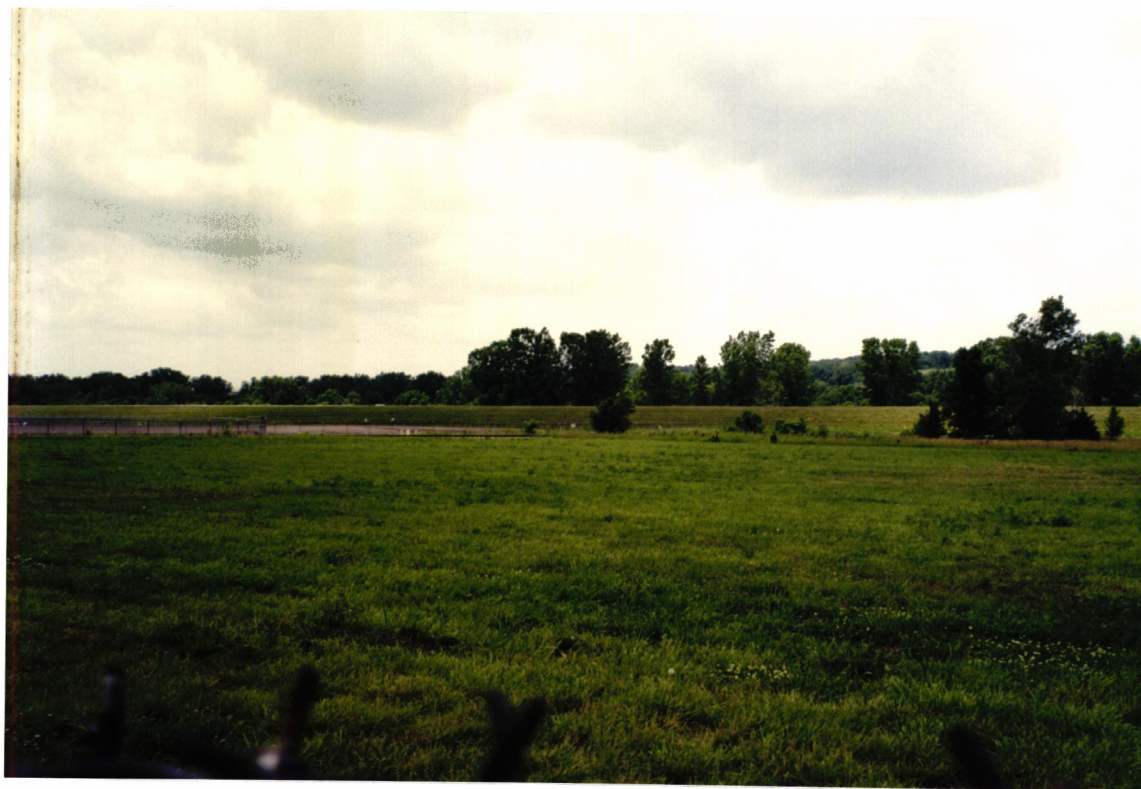
11

Subject: The former THAN surface impoundment from the northeast corner of the DAITOM property.

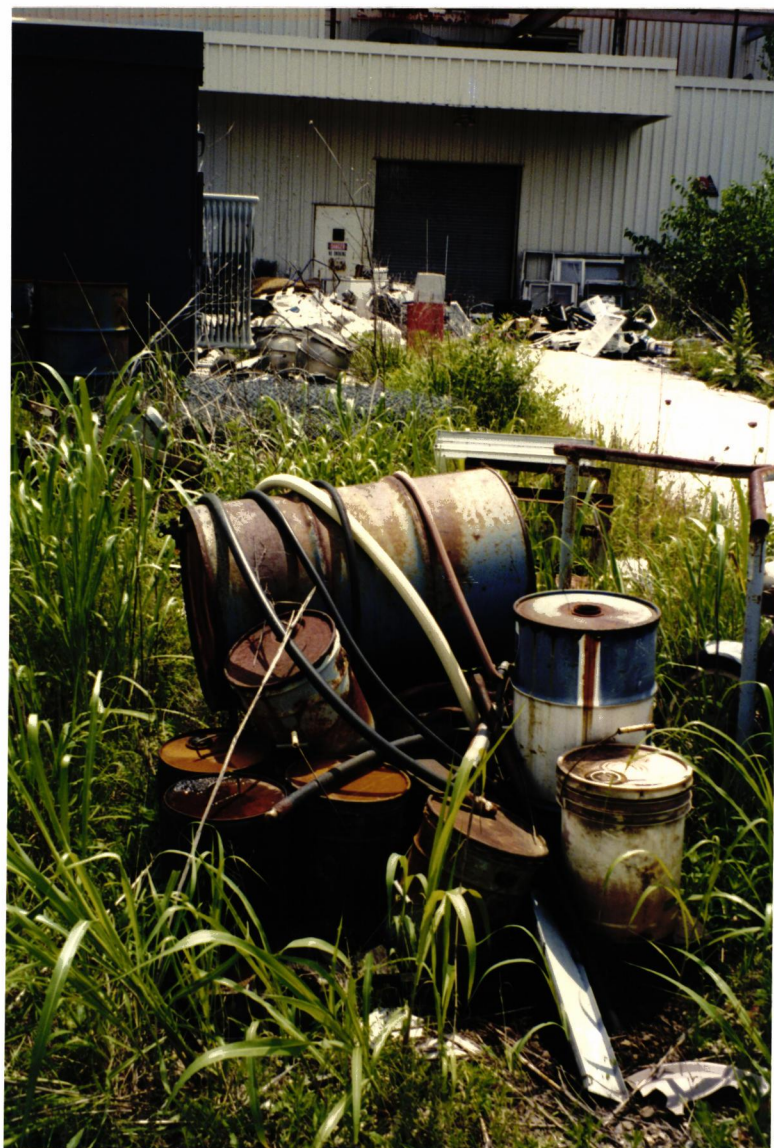
Subject: Containers of used oil and paint cans to the north of the former DAITOM plant.

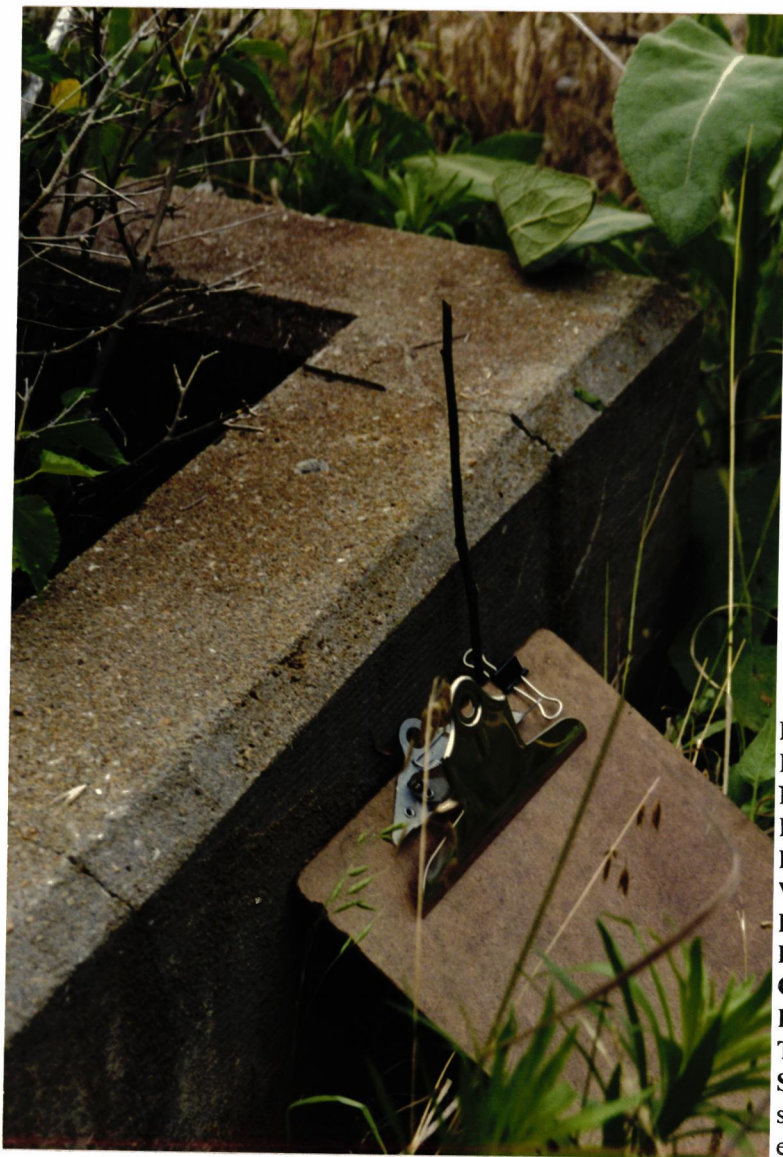
ROLL 3 PHOTO 14

Subject: A crack in the northeast corner of the secondary containment berm around the former ethyl acetate recovery pad.

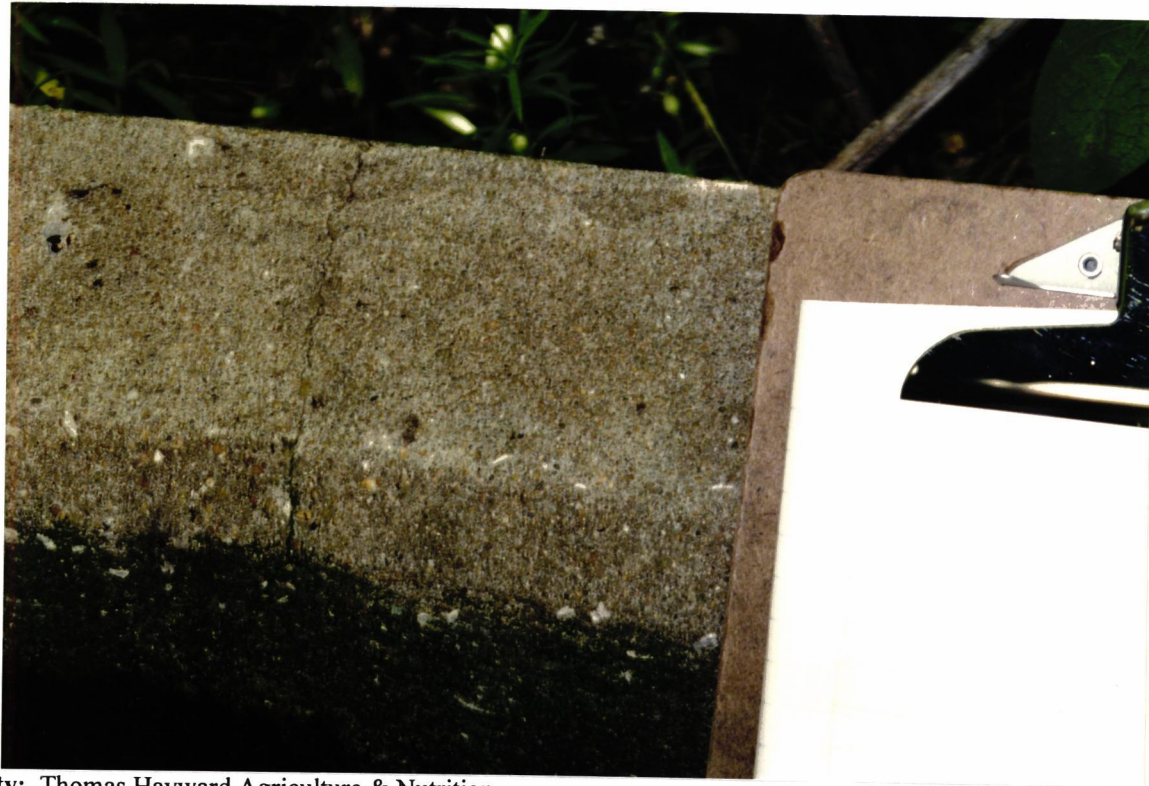
Subject: A crack in south side of the secondary containment berm around the former methanol recovery pad.

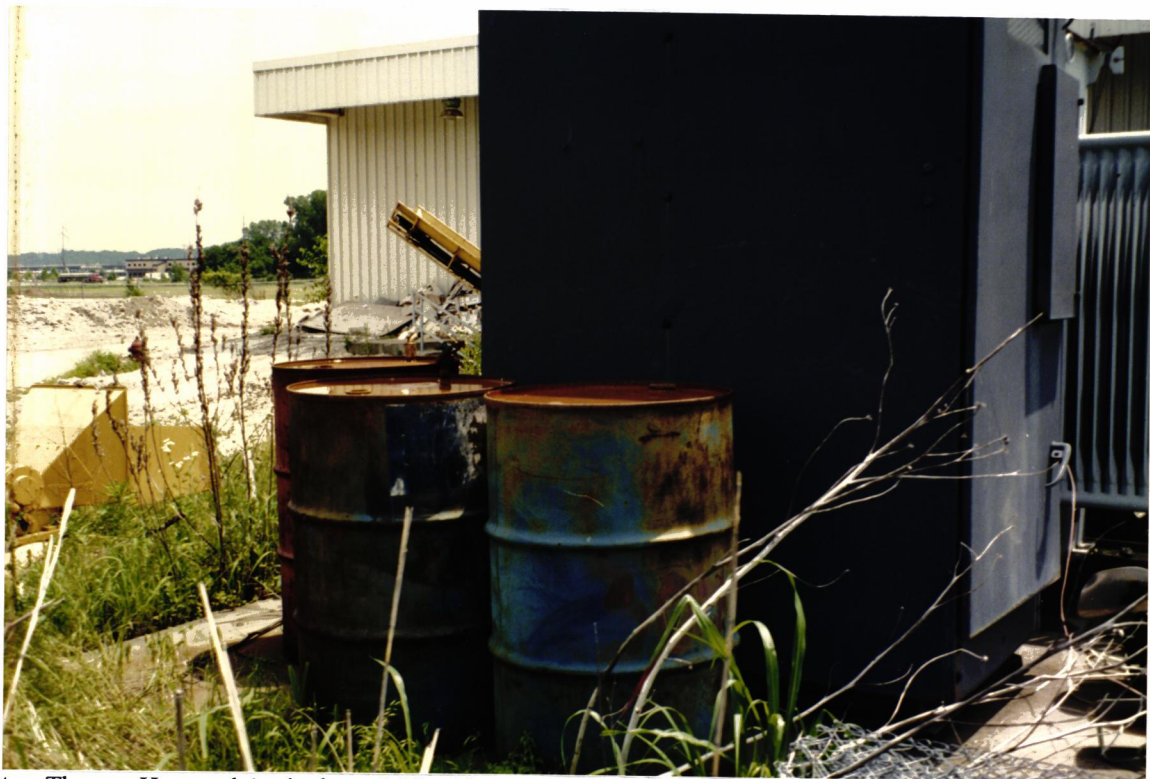
13

Subject: Three drums of unknown material located to the north of the former DAITOM plant adjacent to a electric transformer.

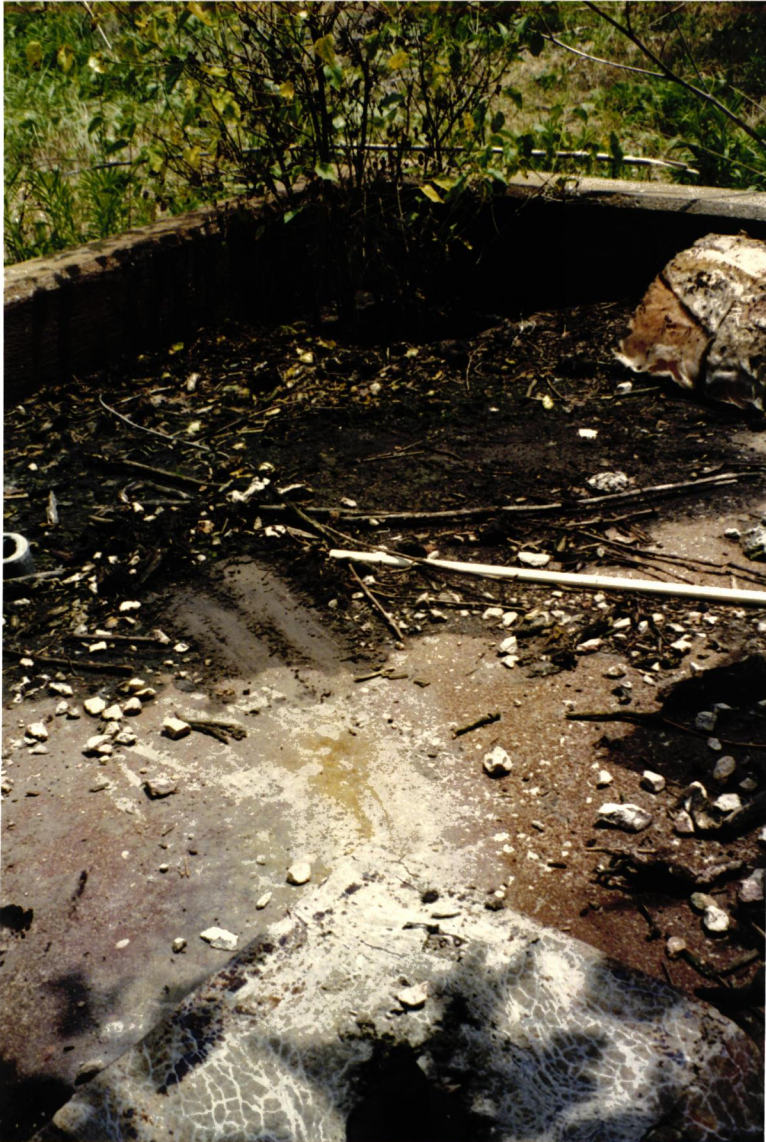
ROLL 3 PHOTO 16

Subject: A hole in ground between former cyanide destruction unit and the former ethyl acetate recovery pad. Pipes are seen leading from the former cyanide destruction unit into the hole. The pipe reportedly connected to the facility sanitary sewer system.

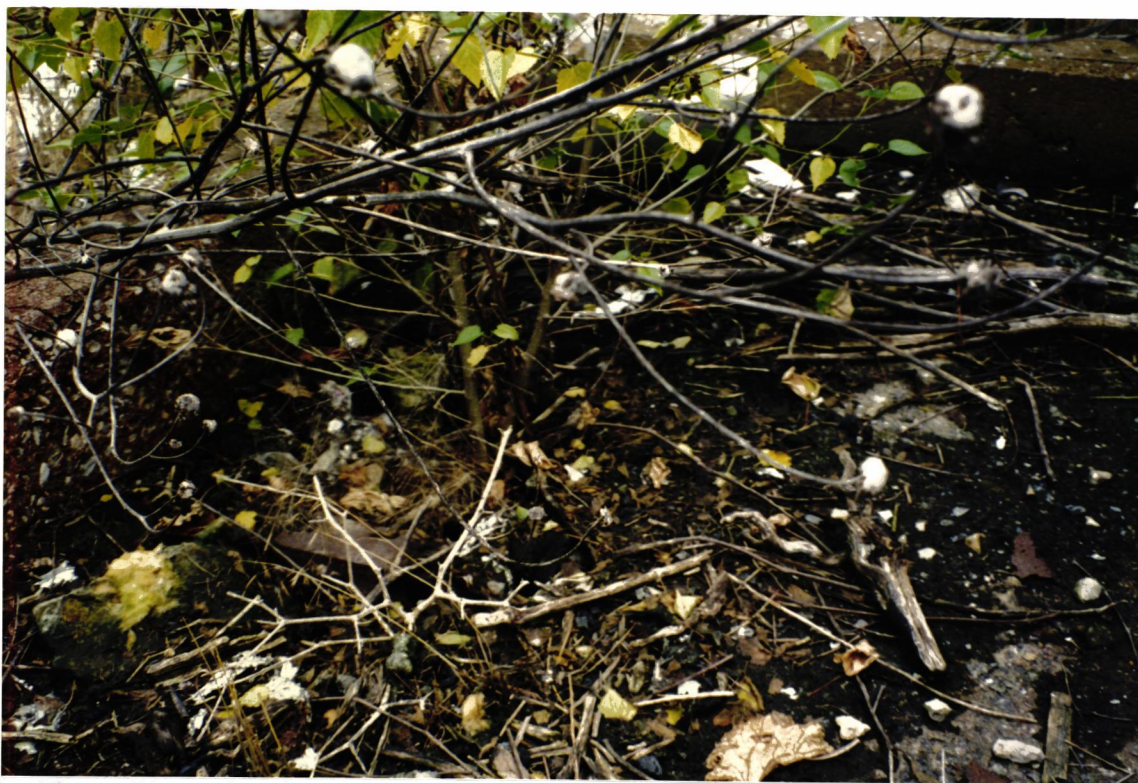
19

Facility: Thomas Hayward Agriculture & Nutrition
Location: Kansas City, KS **Photographer:** Jeffery Robichaud **Witness:** James Aycock **Date:** 6/27/95
Direction: N/A **Camera Type:** Fuji 35mm **Film Type:** 200 ASA **Time:** 1432
Subject: The secondary containment drain (left side of the photo) located near the northeast corner of the former cyanide destruction unit pad.

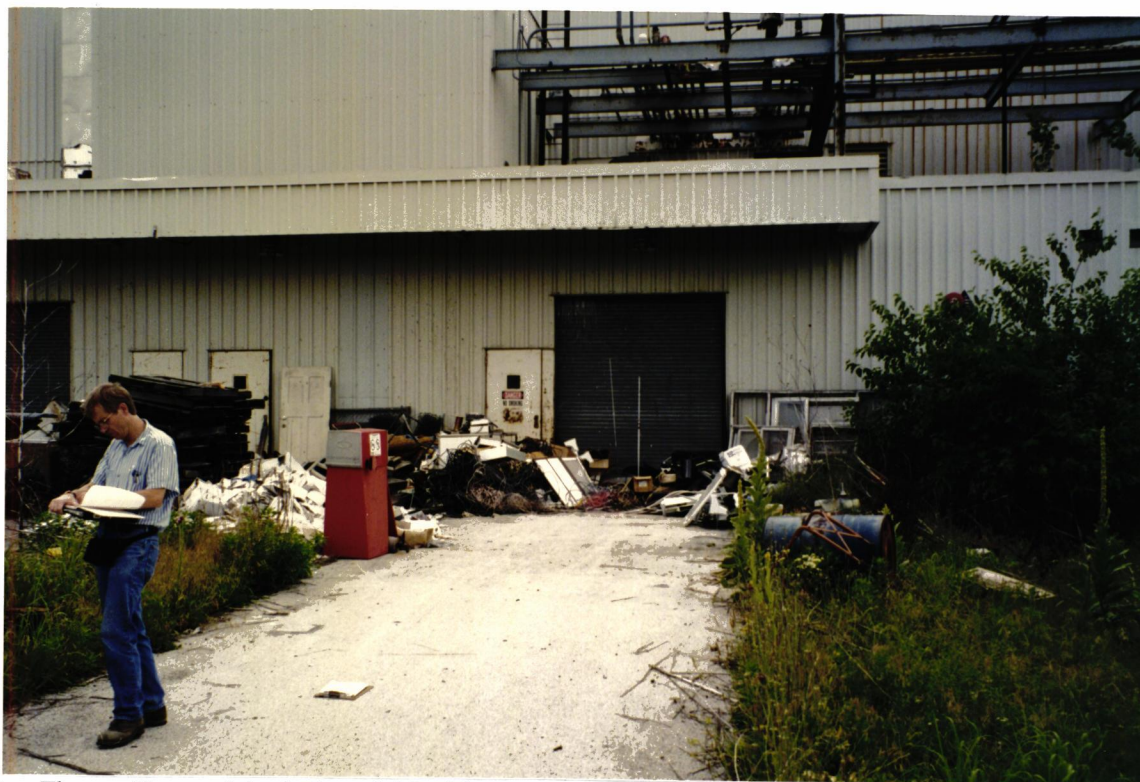
20

Facility: Thomas Hayward Agriculture & Nutrition
Location: Kansas City, KS **Photographer:** Jeffery Robichaud **Witness:** James Aycock **Date:** 6/27/95
Direction: South **Camera Type:** Fuji 35mm **Film Type:** 200 ASA **Time:** 1440
Subject: Loading dock area behind the former DAITOM plant. Note the salvage/scrap material piled around the building.

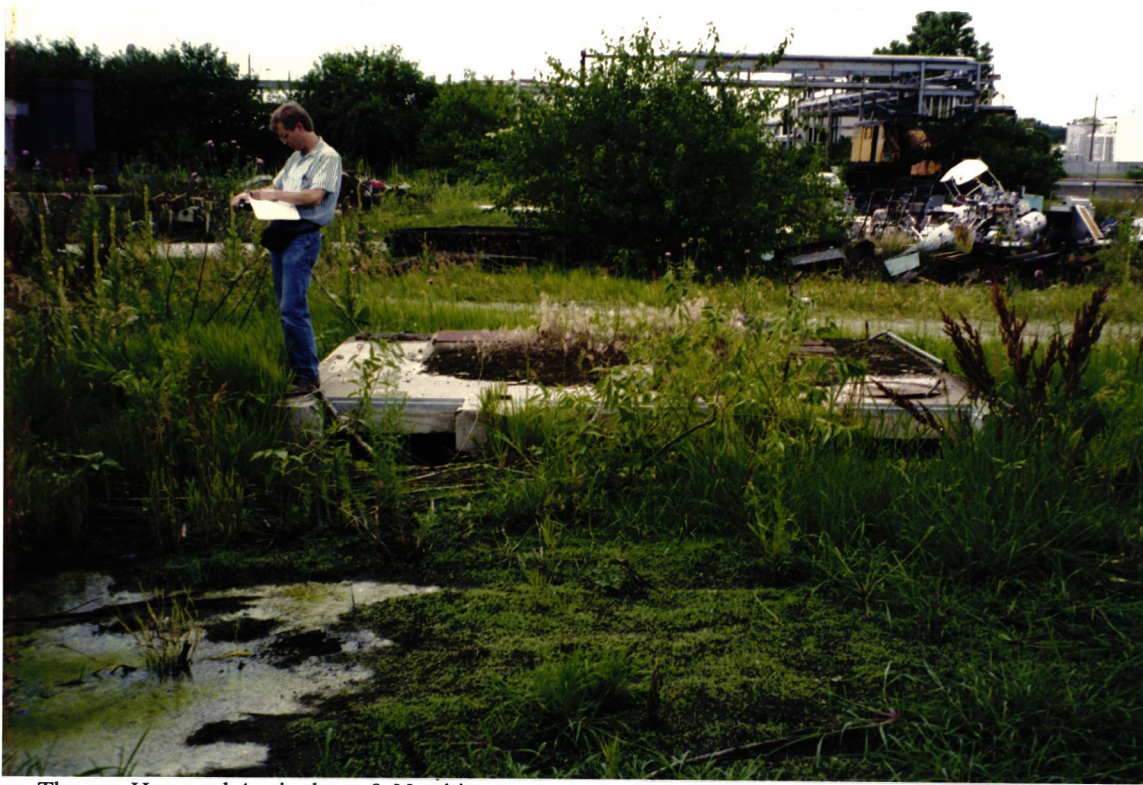
21

Facility: Thomas Hayward Agriculture & Nutrition
Location: Kansas City, KS **Photographer:** Jeffery Robichaud **Witness:** James Aycock **Date:** 6/27/95
Direction: West **Camera Type:** Fuji 35mm **Film Type:** 200 ASA **Time:** 1443
Subject: A concrete pad or underground vault (tank) northeast of the former DAITOM plant.

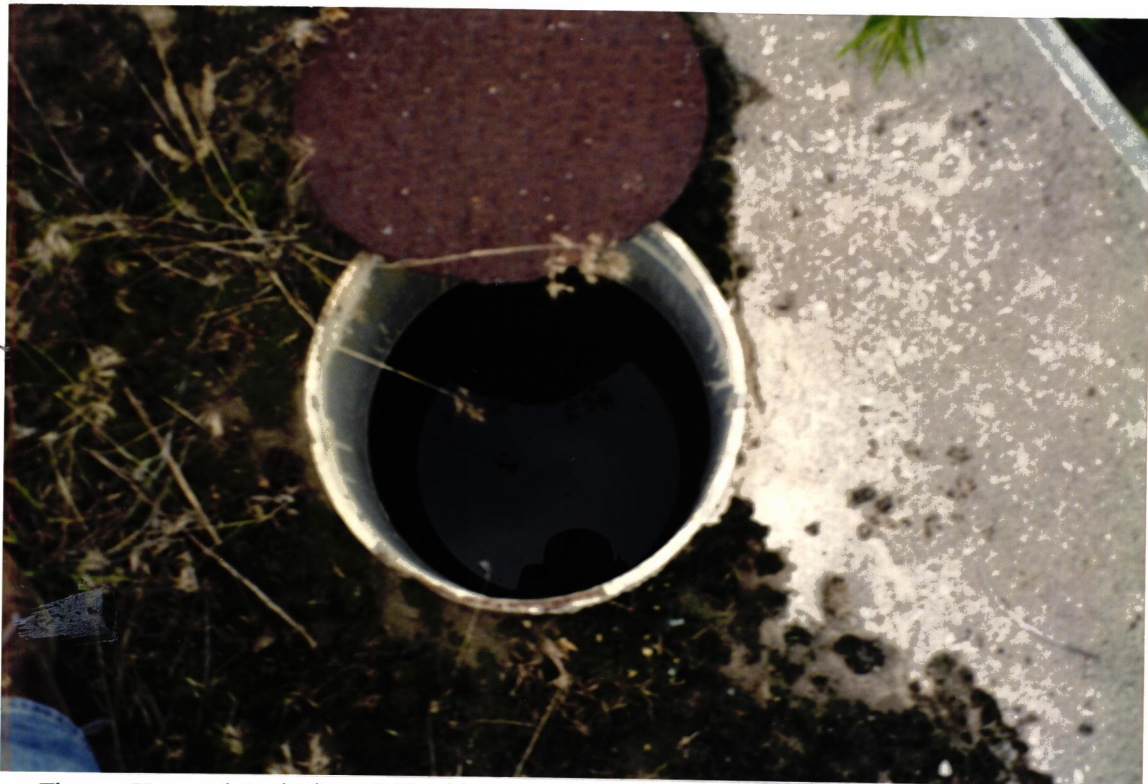
Facility: Thomas Hayward Agriculture & Nutrition
Location: Kansas City, KS **Photographer:** Jeffery Robichaud **Witness:** James Aycock **Date:** 6/27/95
Direction: N/A **Camera Type:** Fuji 35mm **Film Type:** 200 ASA **Time:** 1444
Subject: Open manhole cover in the concrete pad or vault (tank) located to the northeast of the former DAITOM plant. Note the tank or vault was full of water.

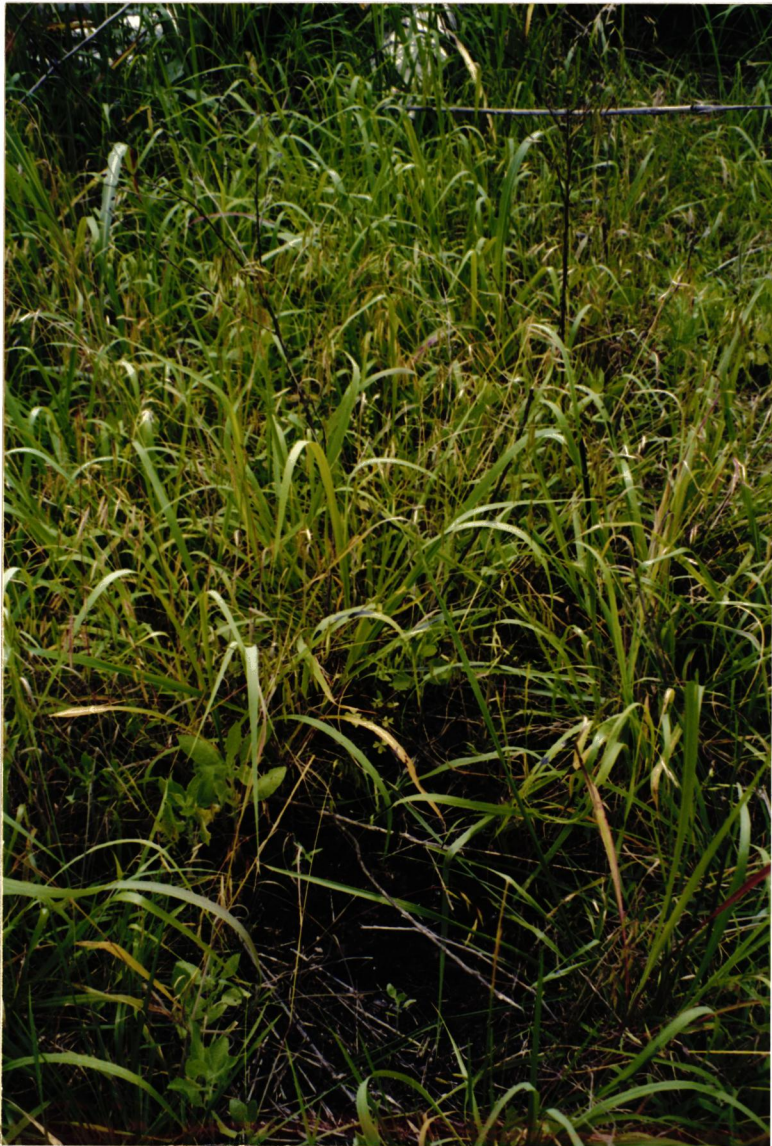
ROLL 3 PHOTO 25

Subject: Black substance staining the soil and vegetation between the #5 diesel fuel tank and the former boiler building. The substance was leaking from an overhead pipeline leading from the #5 diesel fuel tank to the former boiler building.

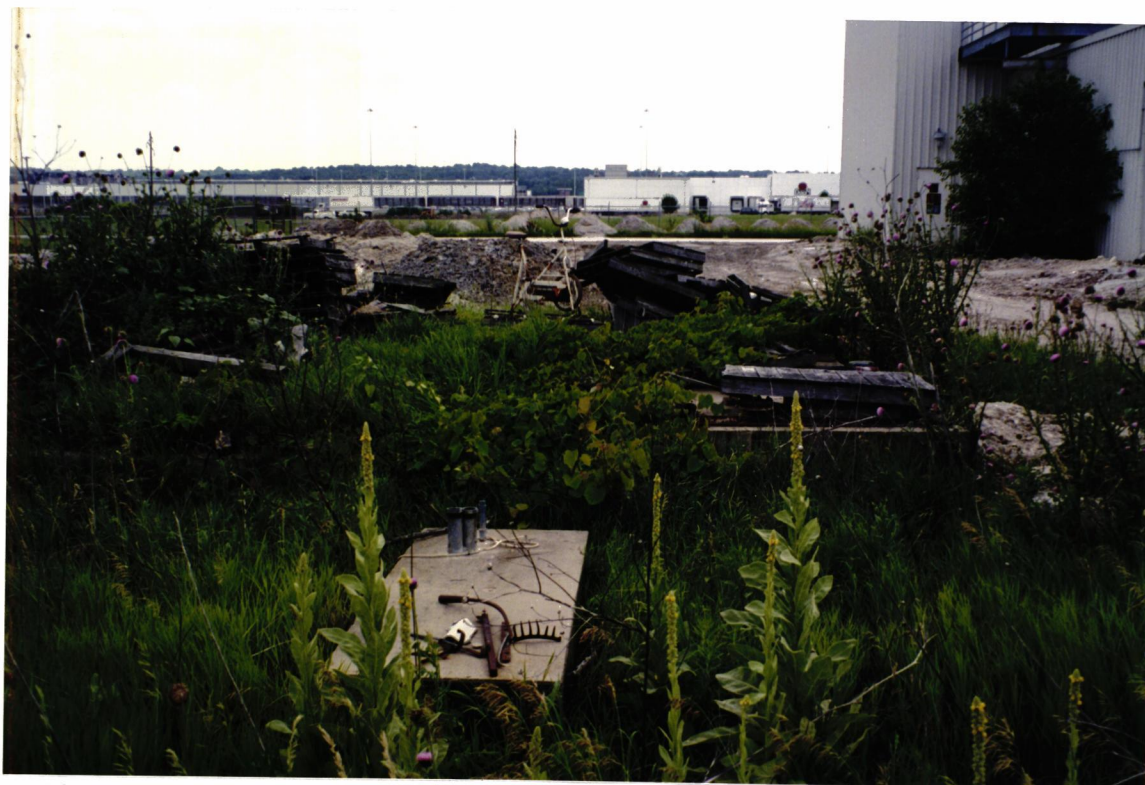
R
O
L
L
3
P
H
O
T
O
23

Subject: Two concrete pads located northeast of the former DAITOM plant. Photo taken from pad in photo 21, 22.

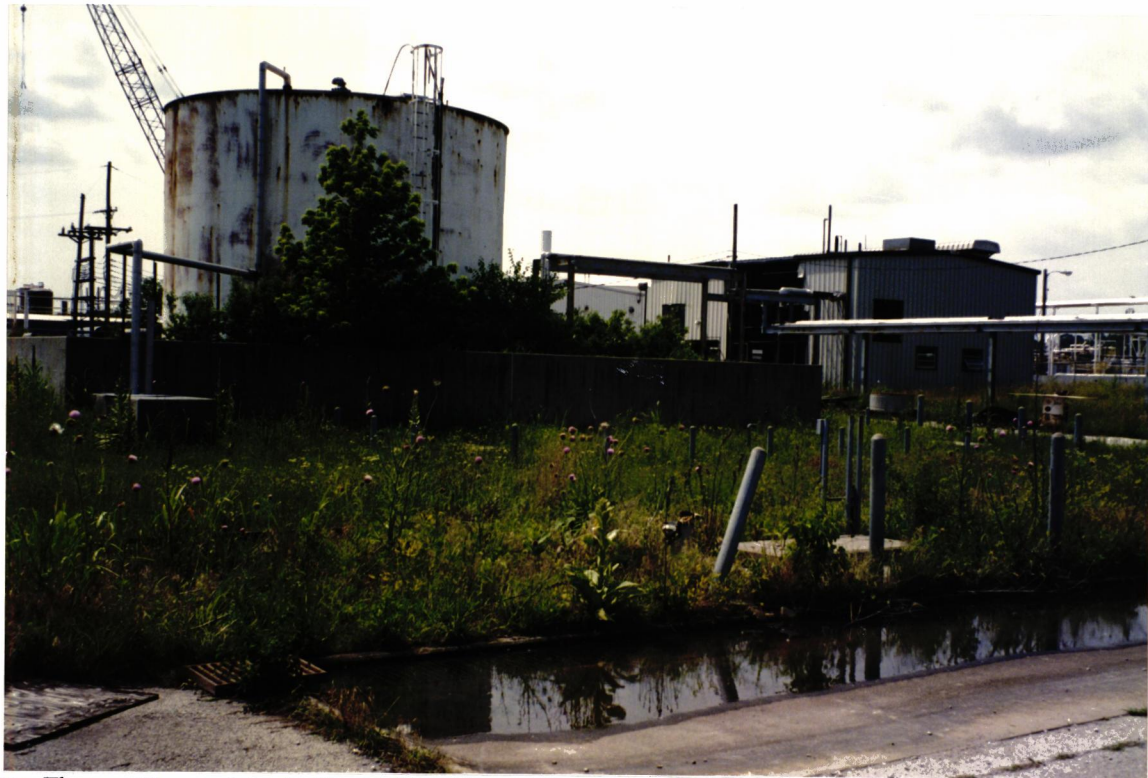
Subject: #5 diesel fuel tank and the former boiler building (at the right side of the photo) and a sump or drain in the foreground. The sump was utilized for catching leaks during railcar/truck off-loading or loading products or materials.

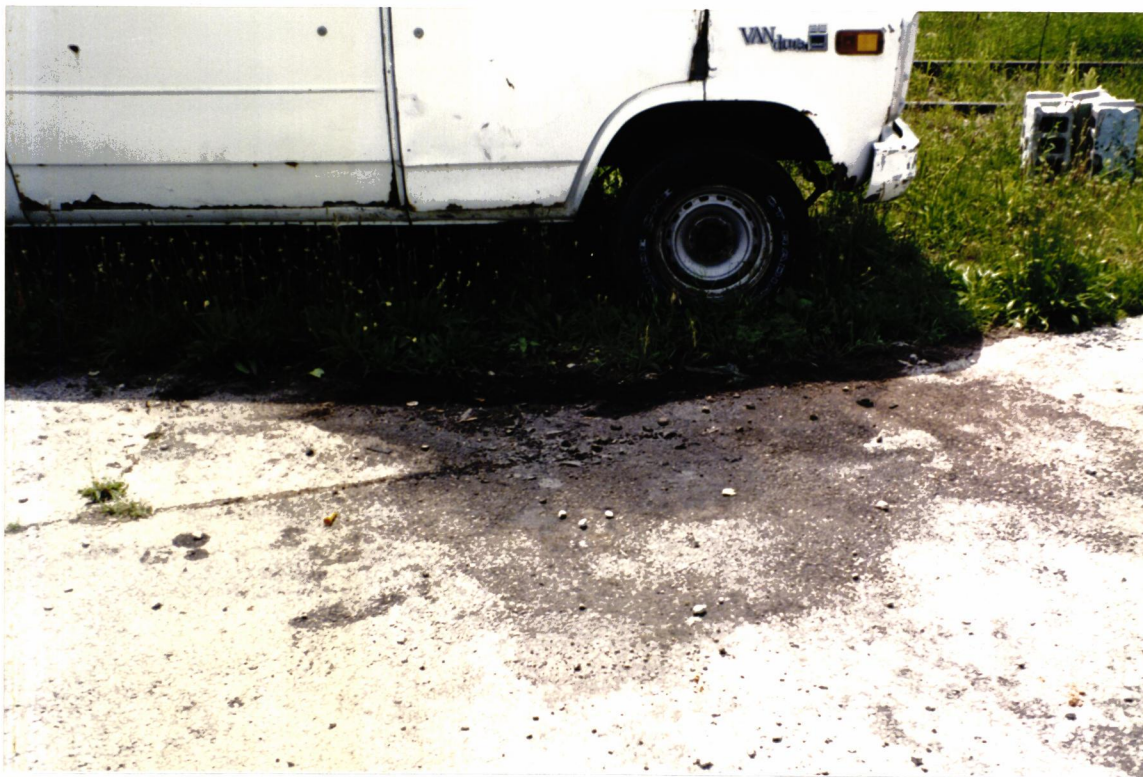
Subject: Used oil stain at southwest corner of the road between the former laboratory/office building and the former boiler building..

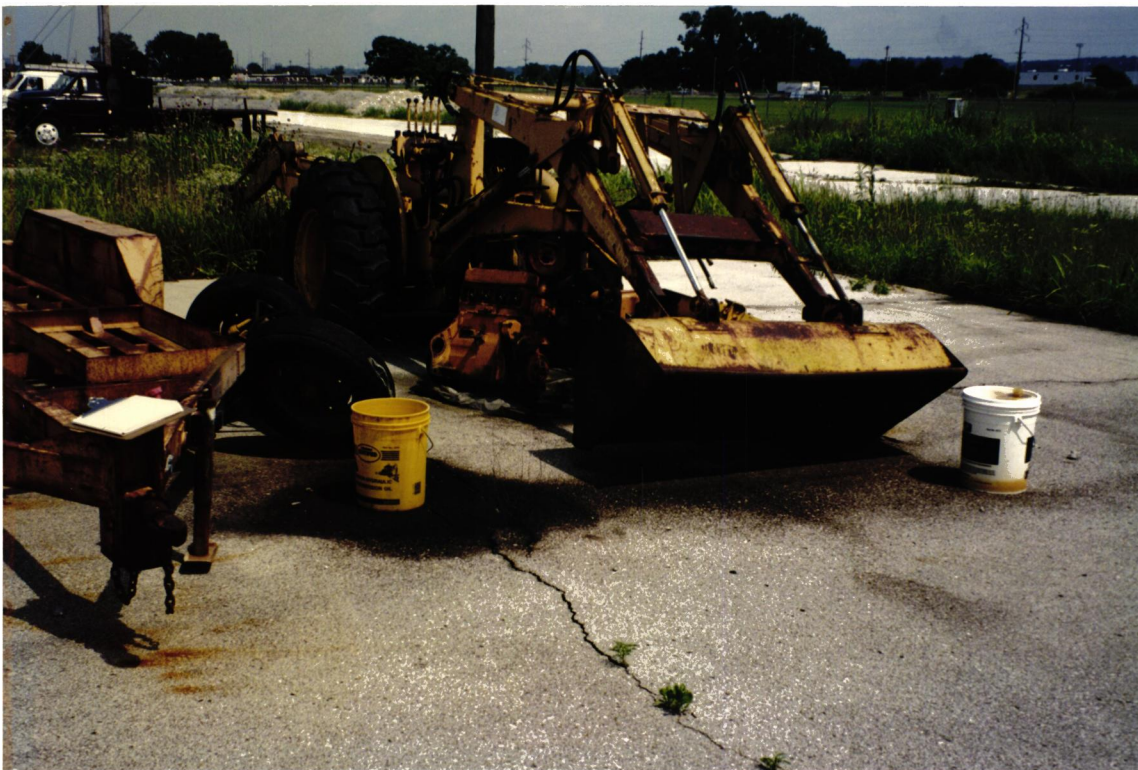
4

Subject: Southeast corner of the parking lot located west of the former laboratory/office building. Note the crack in the asphalt and the used oil stain in the center of the photo.

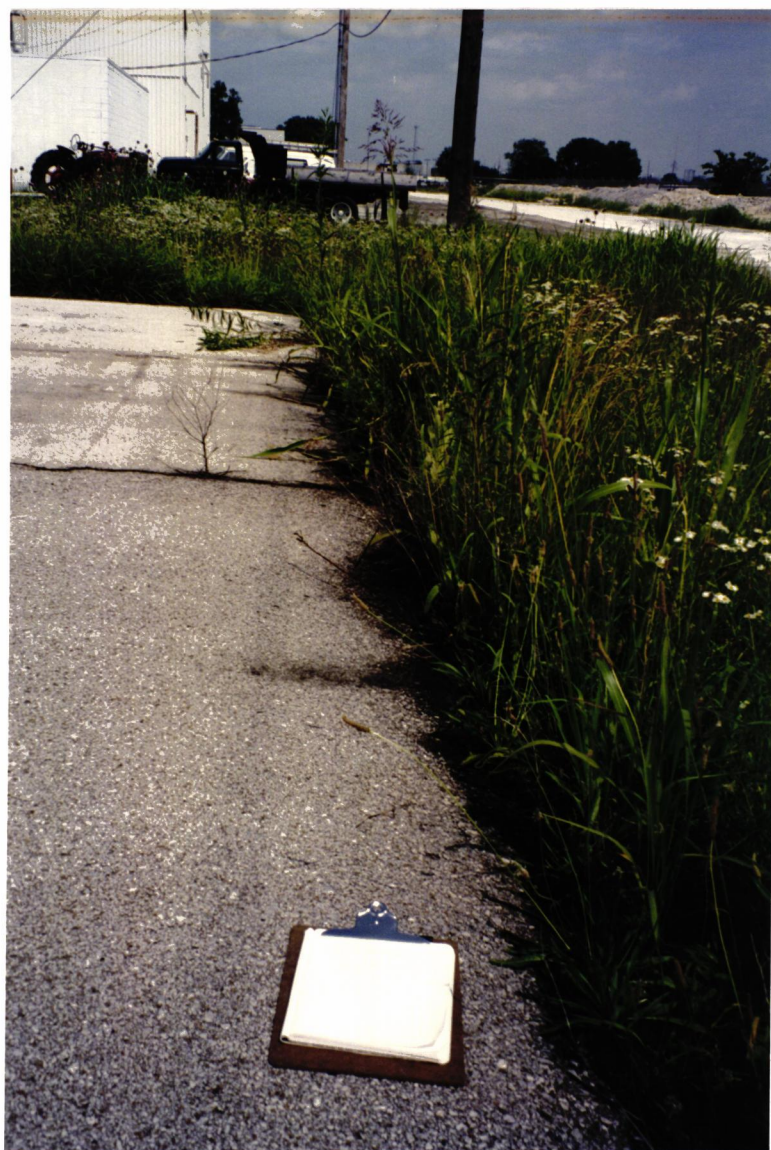
ROLL 4 PHOTO 5

Subject: Crack in parking lot (south center portion of the parking lot). Note the crack appears to be stained with used oil.

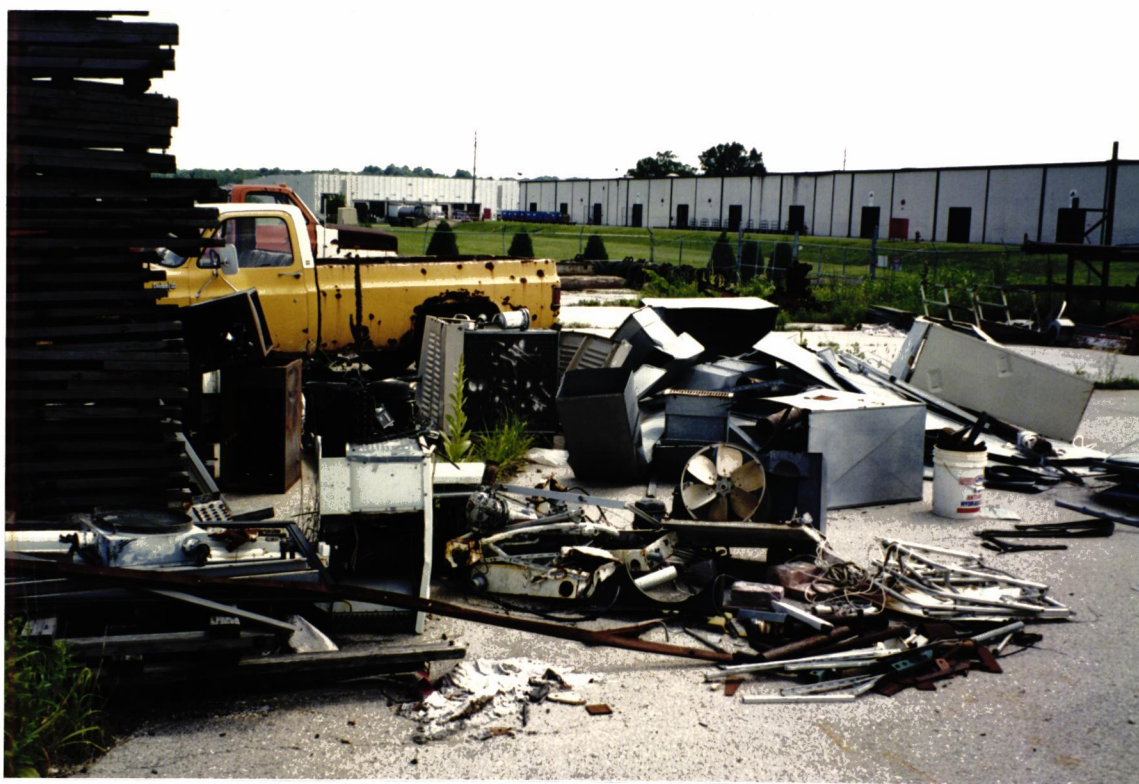
Subject: Scrap/salvaged air conditioning units located near the south side of the parking lot west of the former laboratory/office building. Note: Capacitors had not been removed from the air conditioning units.

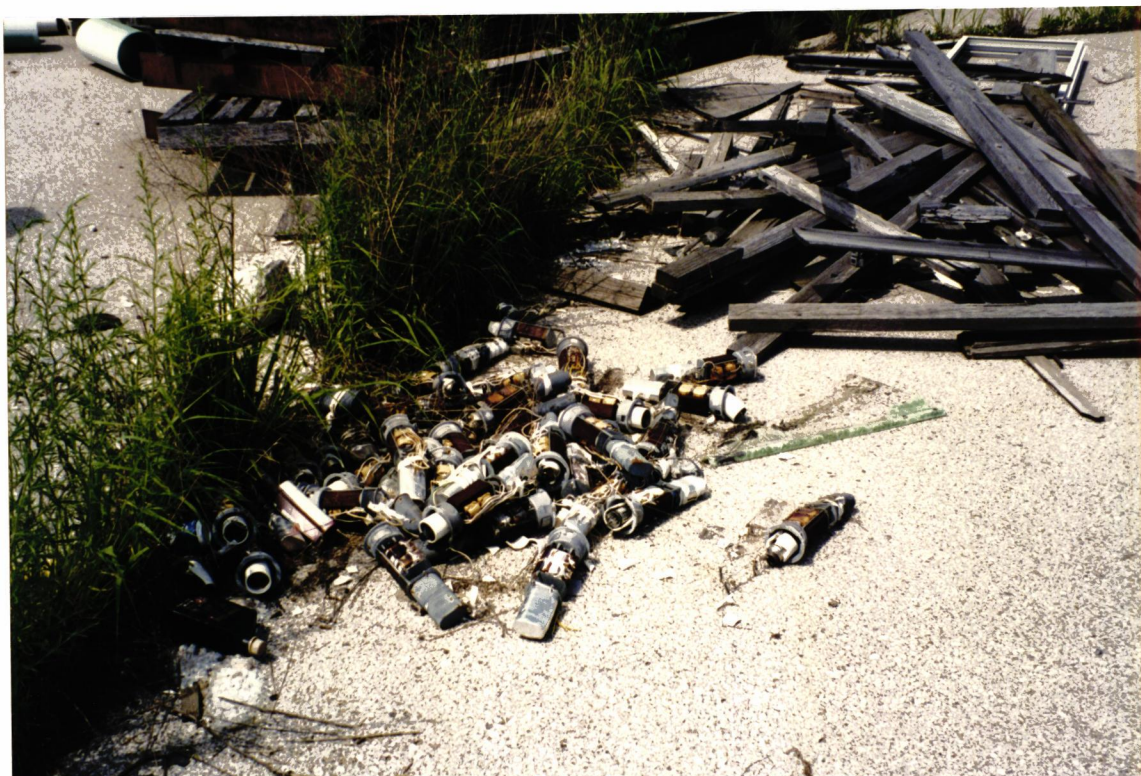
Subject: A close-up of the three different capacitors found in the pile in the middle of the parking lot, west of the former laboratory/office building.
